Fermilab FERMILAB-Conf-06/415-AD November 2006

BEAM-INDUCED DAMAGE TO THE TEVATRON COMPONENTS AND WHAT HAS BEEN DONE ABOUT IT

N.V. Mokhov[†], P.C. Czarapata, A.I. Drozhdin, D.A. Still, FNAL, Batavia, IL 60510, USA R.V. Samulyak, BNL, Upton, NY 11973, USA

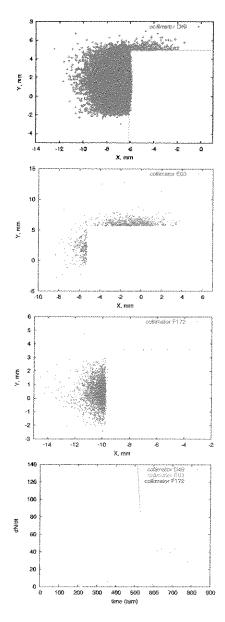
Particle hits at the collimators and a hits time distribution are shown in Fig. 4. The entire beam is lost during about 400 turns (8.4 msec) starting from the turn number 400, mostly on the D49 primary collimator and EØ3 and F17(2) secondary collimators.

Figure 4: Particle hits at A48 cell quench in the collimators D49, E03 and F17(2), and hits time distribution.

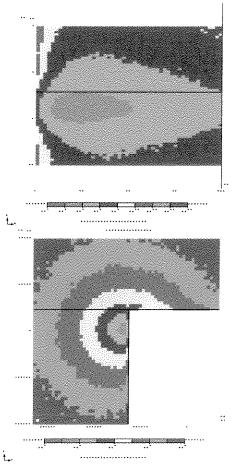
Calculations performed for the 1.5-m long L-shaped secondary collimators E03 and F17(2) have shown (Fig. 6) that a 250-mm long and 3-mm wide slot is created in the stainless steel collimator vertical jaws.

Figure 6: Energy deposition isocontours along the vertical jaw of E03 (top) and at shower maximum across the F17(2) (bottom) collimators.
